7.7 List of Figures

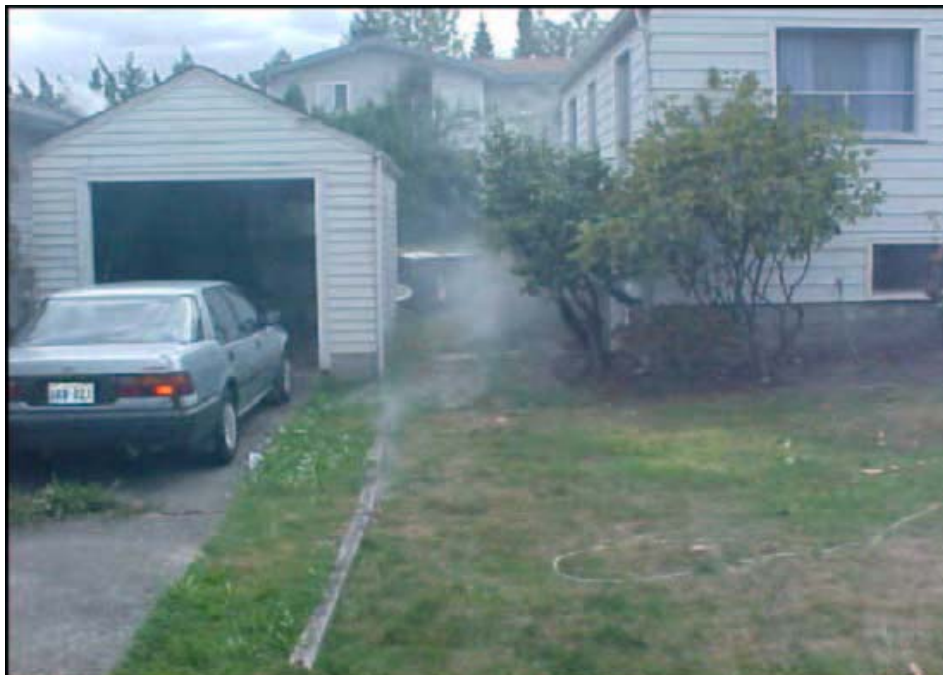
Figure 7-2. Smoke Testing 1

Smoke emanating from ground during smoke testing indicating cracks or defects in the buried side sewer.

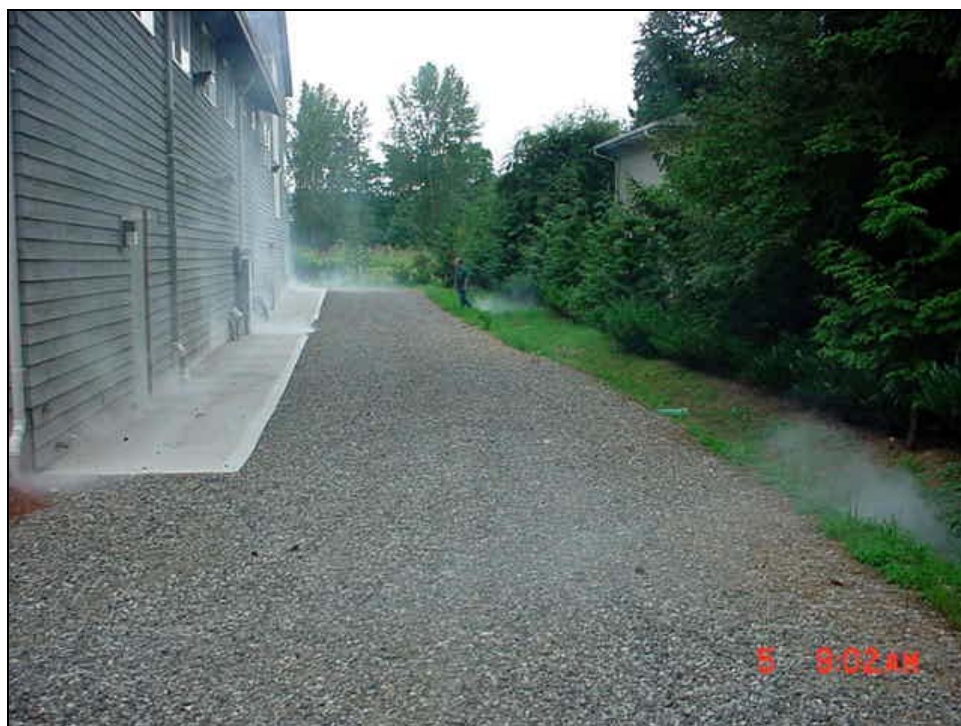
Figure 7-3. Smoke Testing 2

Smoke emanating from ground during smoke testing.

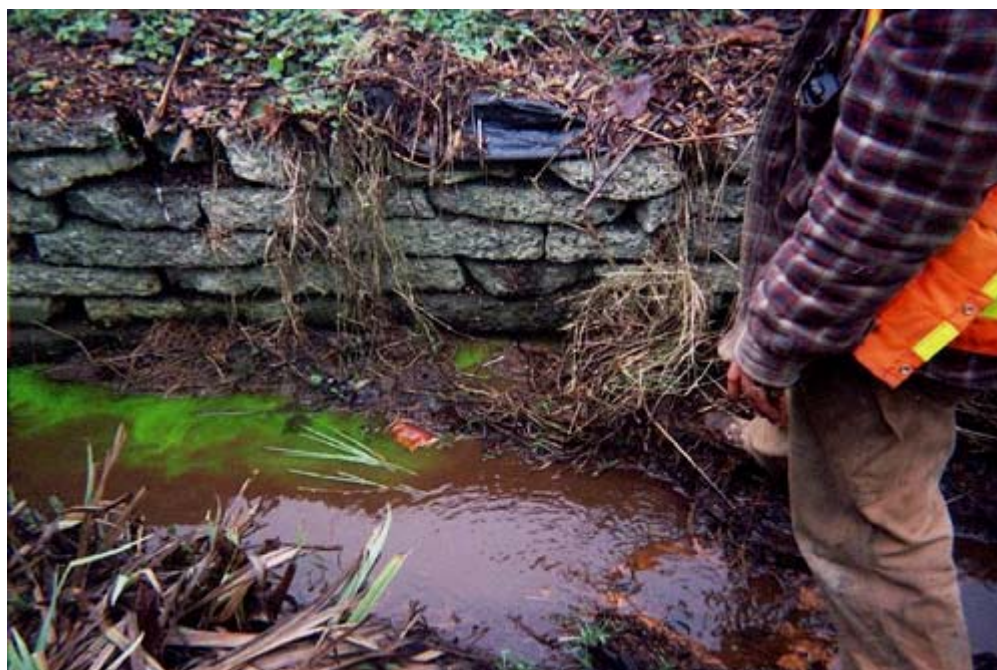
Figure 7-4. Dye Testing

Dye testing confirming down spout connected to ditch rather than sanitary sewer.

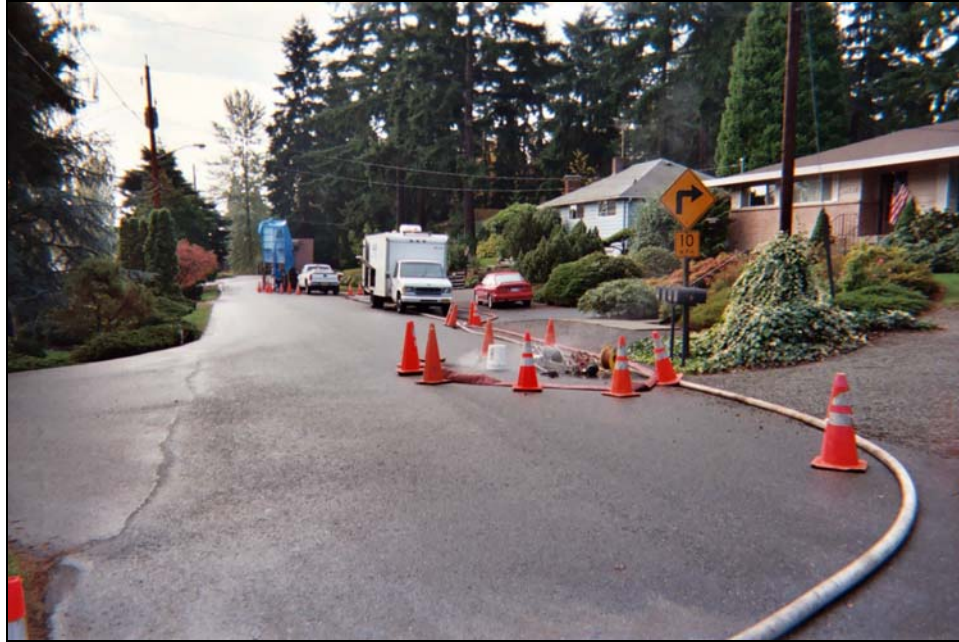
Figure 7-5. Cured-in-Place Pipe 1

Entire operation for installation of one section of sewer main CIPP.

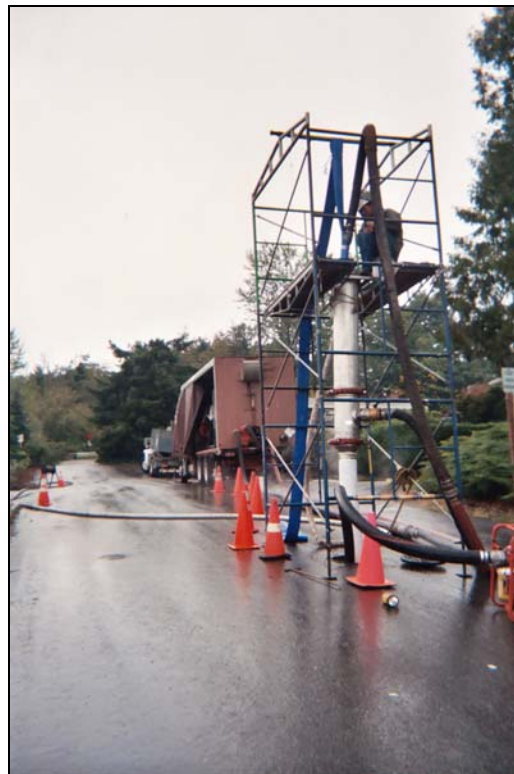
Figure 7-6. Cured-in-Place Pipe 2

Scaffolding supporting water inversion equipment for installation of CIPP in sewer main. Boiler truck is in the background.

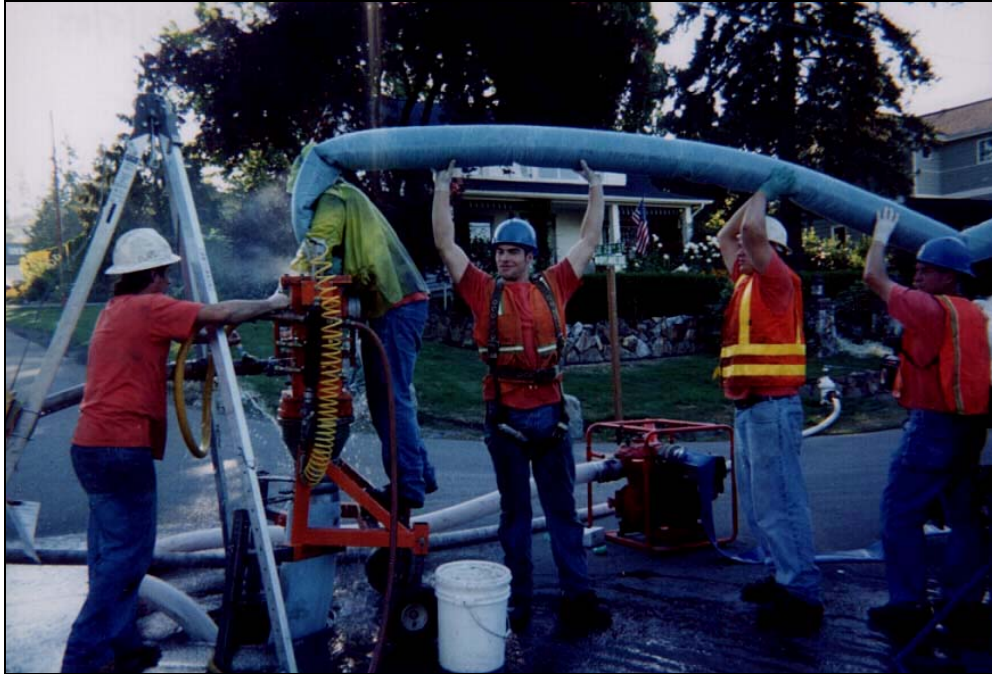
Figure 7-7. Cured-in-Place Pipe 3

Crew installing CIPP using the air inversion method.

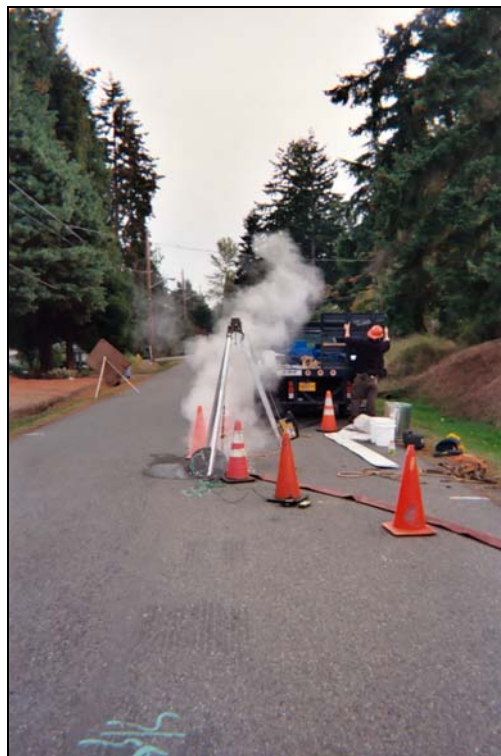
Figure 7-8. Cured-in-Place Pipe 4

Steam exiting tail end of CIPP during the curing process.

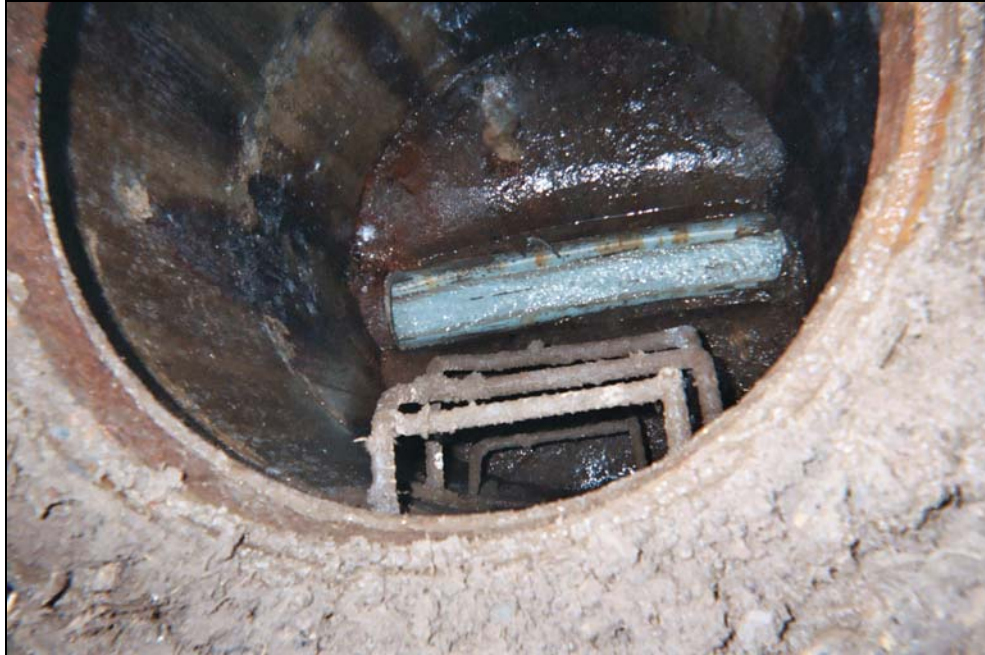
Figure 7-9. Cured-in-Place Pipe 5

CIPP in bottom of channel. Liner was installed through this manhole and the portion of the liner above the spring line of the channel was removed after curing.

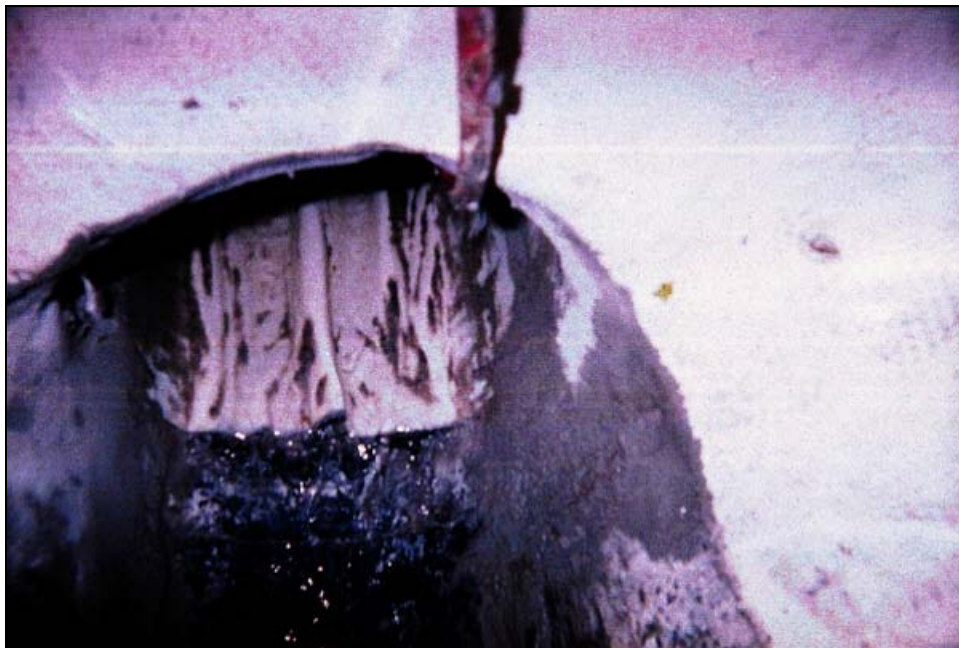
Figure 7-10. Cured-in-Place Pipe 6

Liner failed to fully inflate in this 12-inch-diameter sewer main at downstream manhole. Wrinkles extended several feet up the pipe and were not fully cured. Last run of pipe was re-pressurized and additional steam was applied. Short section of liner was then removed and a spot repair installed.

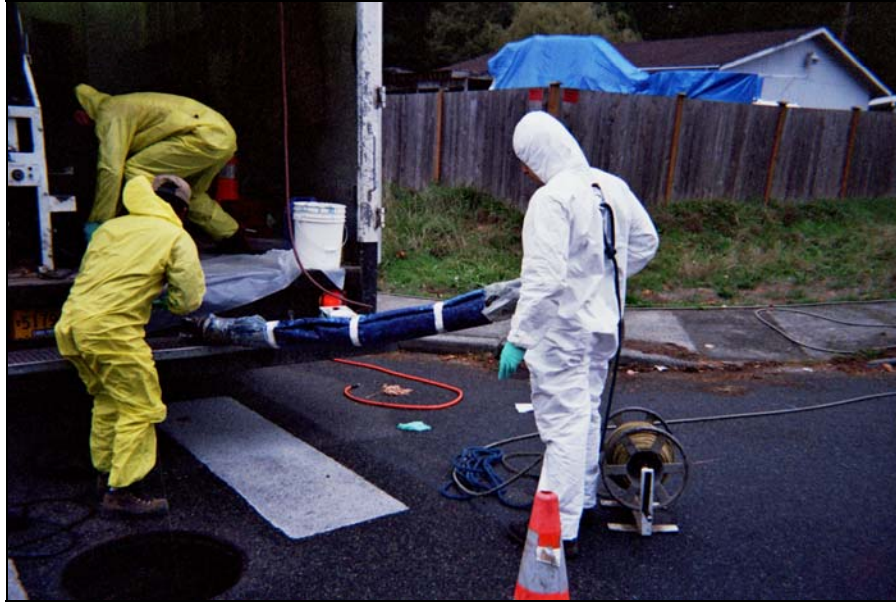
Figure 7-11. Cured-in-Place Pipe 7

A 4-foot section of blue liner wrapped around a packer in preparation for a CIPP spot repair. Blue resin is fast curing epoxy.

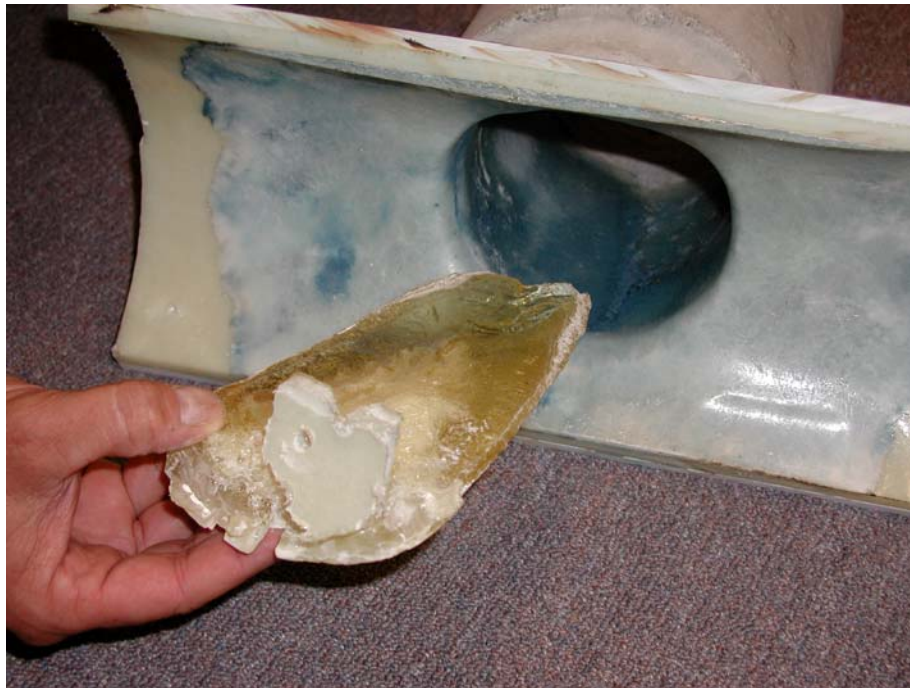
Figure 7-12. Cured-in-Place Pipe 8

Epoxy resin slug that pooled in a lateral connection to a sewer main during the installation of the CIPP in the sewer main. The slug is held adjacent to a sample pipe section with a lateral connection to illustrate the location of the slug in the field. The slug was removed during the reinstatement of the lateral connection.

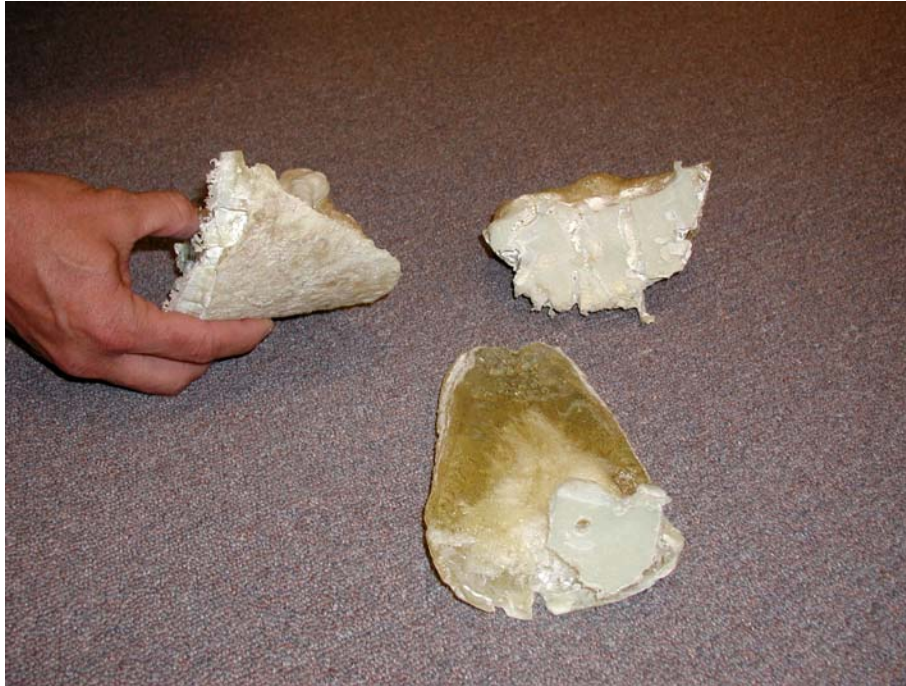
Figure 7-13. Cured-in-Place Pipe 9

Epoxy resin slugs removed from laterals.

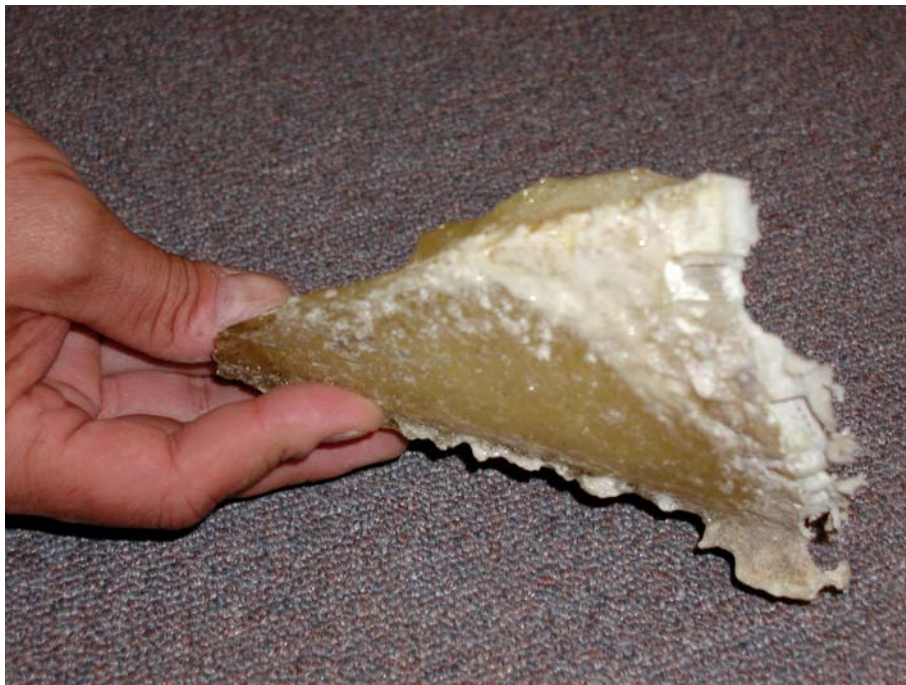
Figure 7-14. Cured-in-Place Pipe 10

Epoxy resin slug removed from laterals.

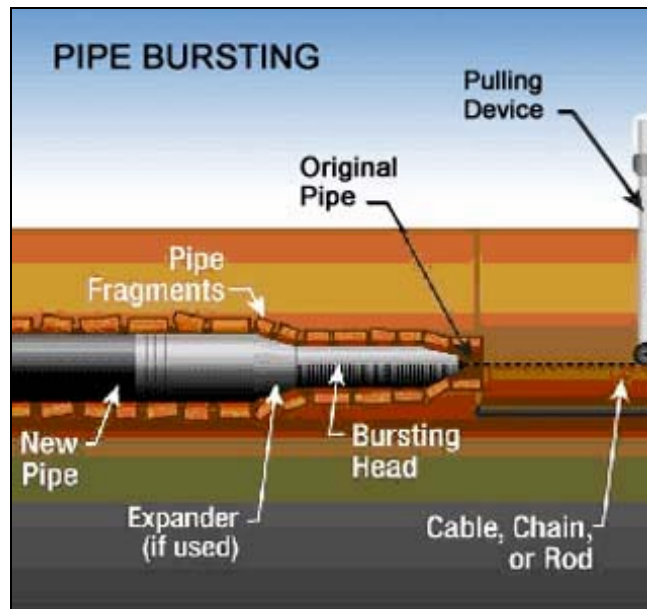
Figure 7-15. Pipe Bursting 1

Schematic of pipe bursting operation.

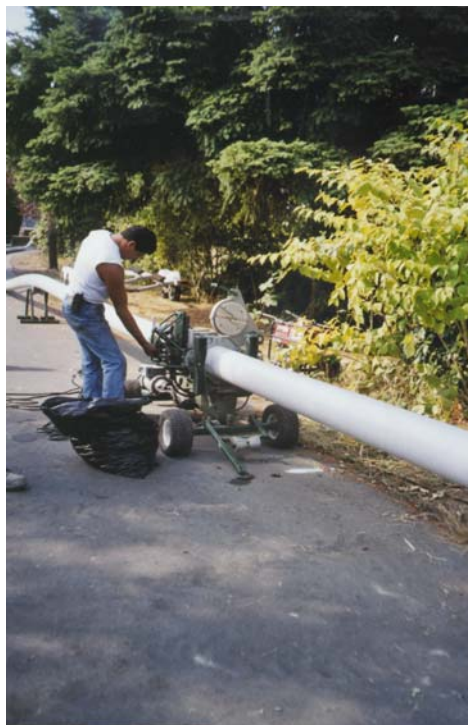
Figure 7-16. Pipe Bursting 2

Gray HDPE sections being welded into long lengths.

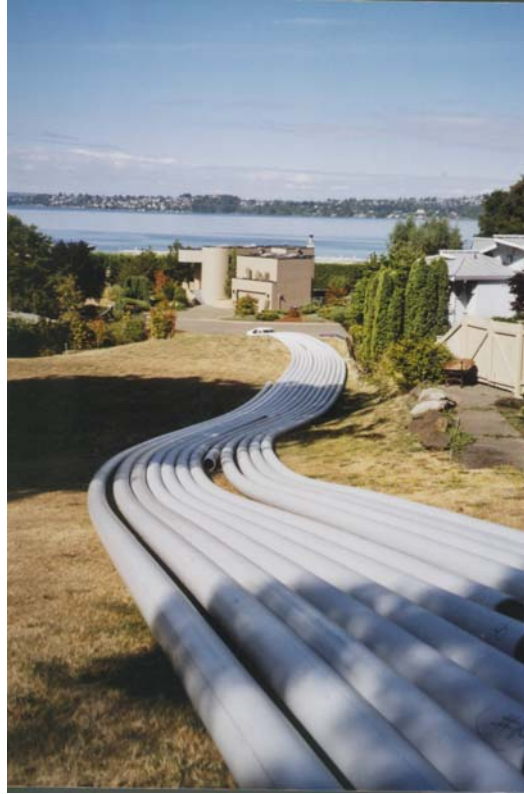
Figure 7-17. Pipe Bursting 3

Sections of welded HDPE ready to be dragged into position.

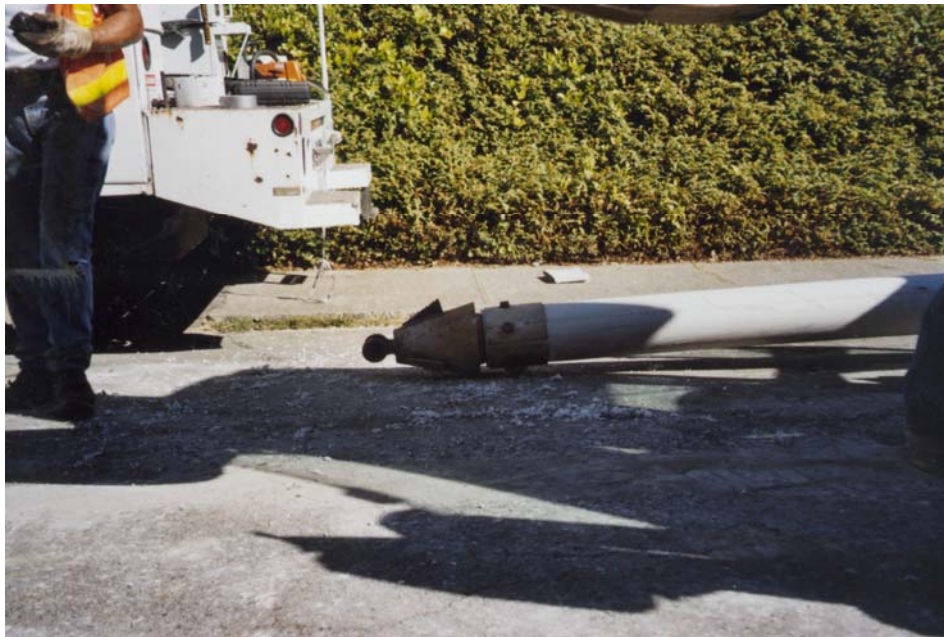
Figure 7-18. Pipe Bursting 4

Pipe bursting head attached to an 8-inch-diameter HDPE pipe. Note extra fins.

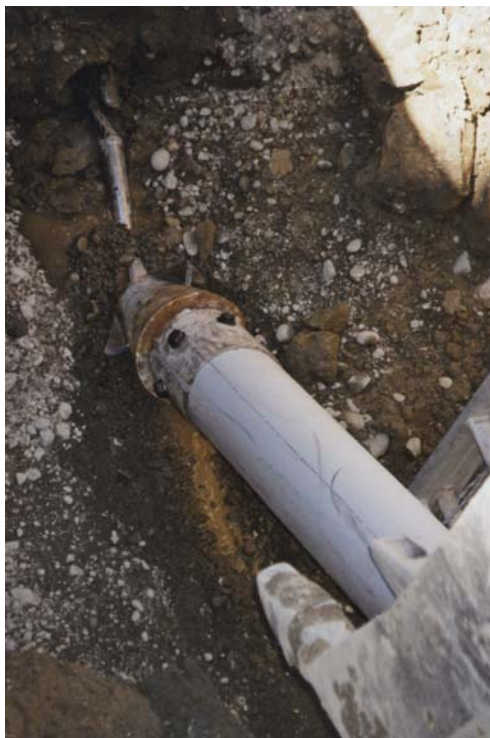
Figure 7-19. Pipe Bursting 5

Pipe bursting head being pulled into position to start the bursting operation.

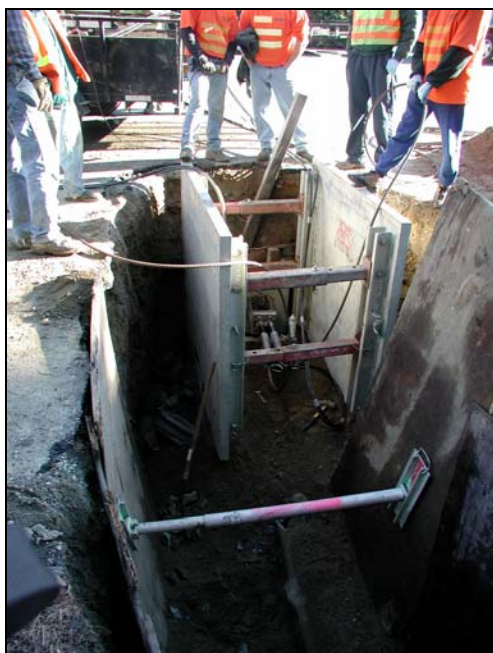
Figure 7-20. Pipe Bursting 6

Small pipe bursting equipment consisting of a pair of 2-foot-long hydraulic cylinders and pressure plate. This equipment is capable of being used inside an existing manhole.

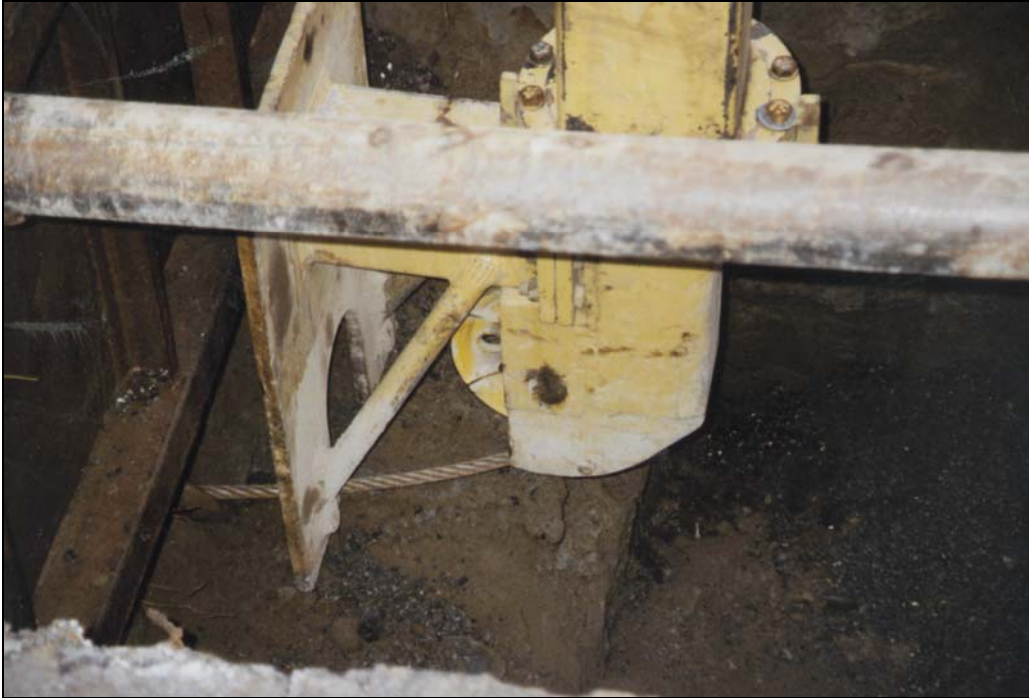
Figure 7-21. Pipe Bursting 7

Pipe bursting pressure plate and cable ready to begin pull.

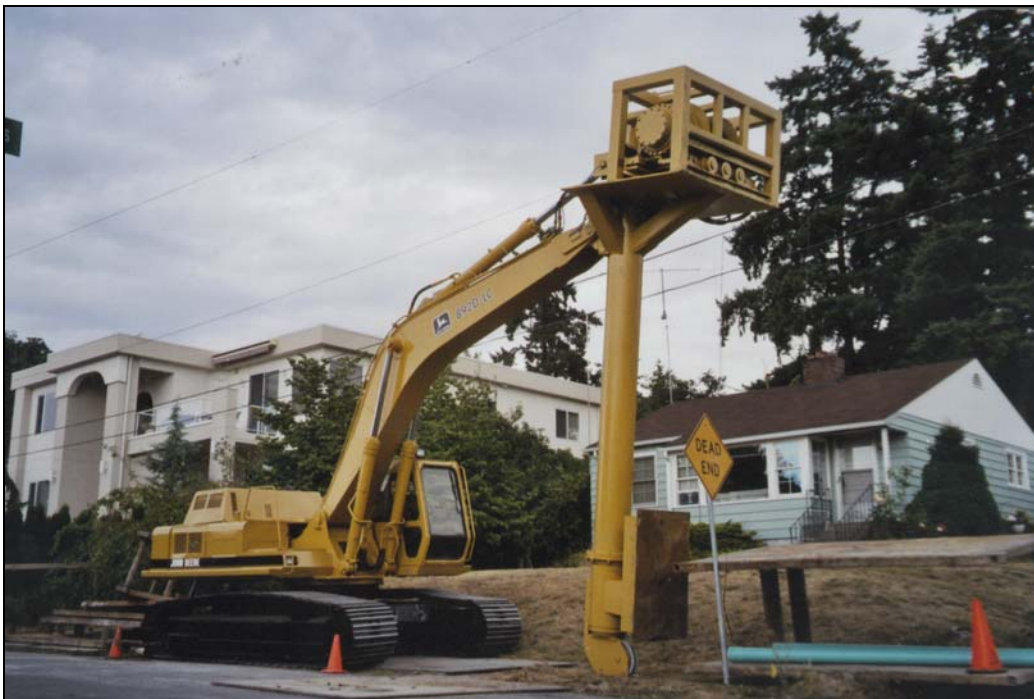
Figure 7-22. Pipe Bursting 8

Trackhoe configured for pipe bursting. Note hydraulic motor, boom, and pressure plate.

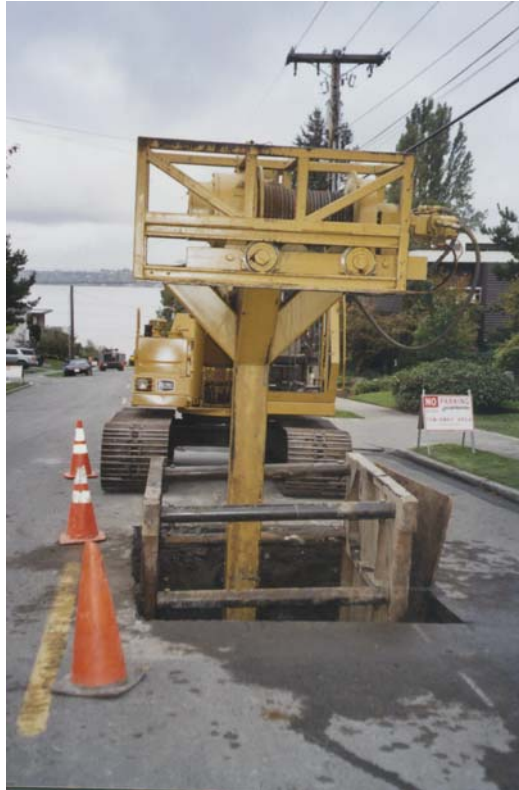
Figure 7-23. Pipe Bursting 9

Trackhoe positioned at pulling pit during pipe bursting.

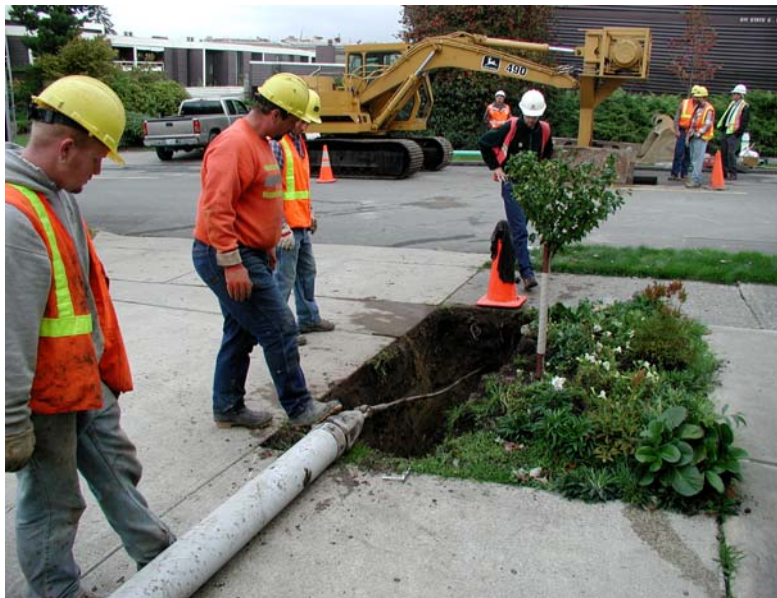
Figure 7-24. Pipe Bursting 10

Pipe bursting of a lateral. Pull was approximately 40 feet long.

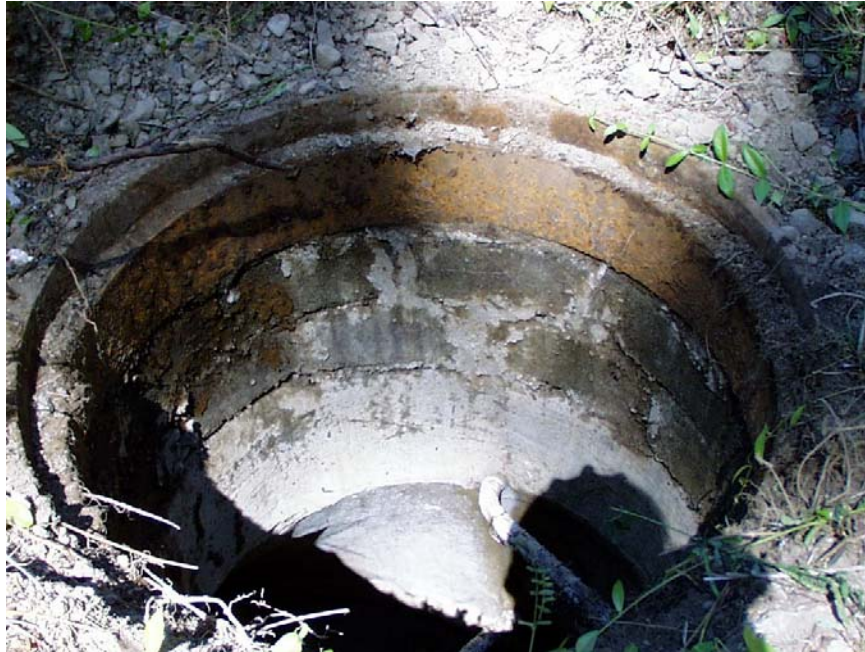
Figure 7-25. Manhole 1

Manhole chimney in need of repair.

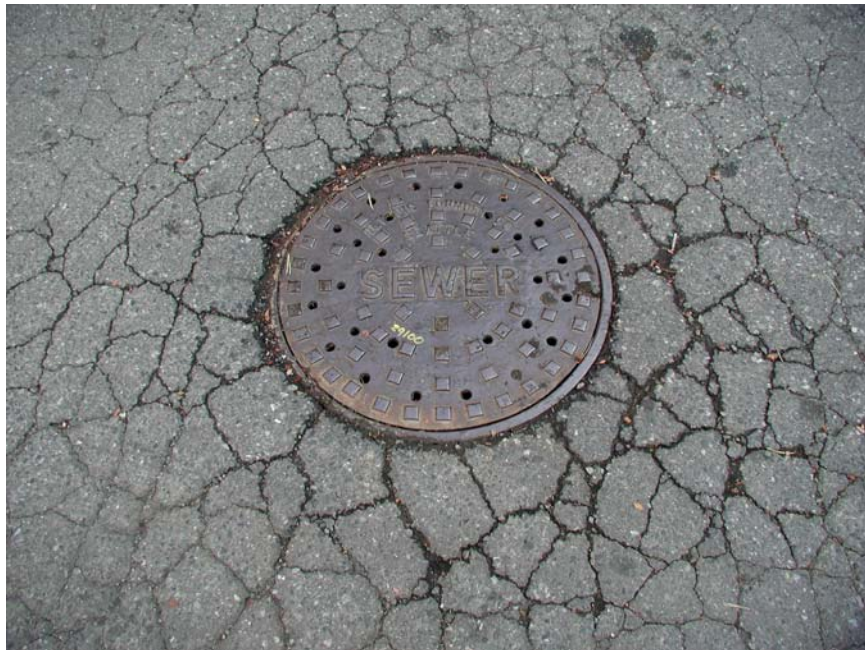
Figure 7-26. Manhole 2

Manhole with indications of settlement in the pavement that likely subject the cover to inundation during rainfall. The large number of pick holes in the lid also allows free flow of surface water into the manhole.

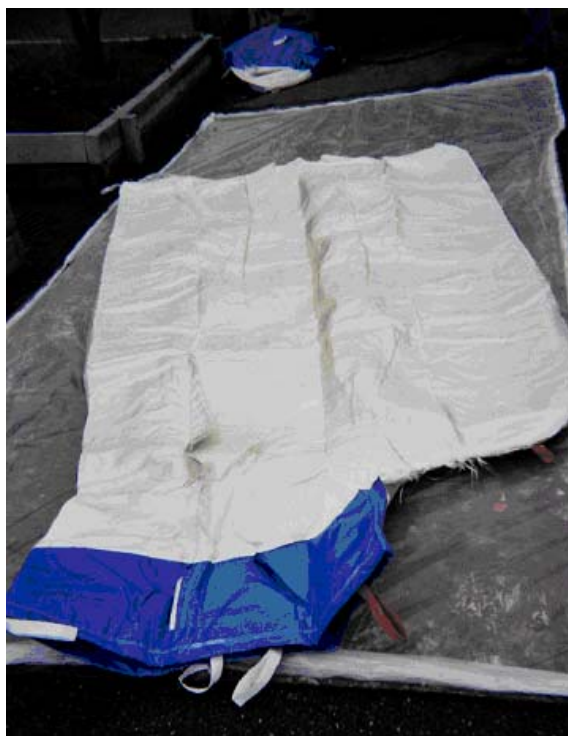
Figure 7-27. Manhole 3

Fiberglass manhole liner prior to wet-out.

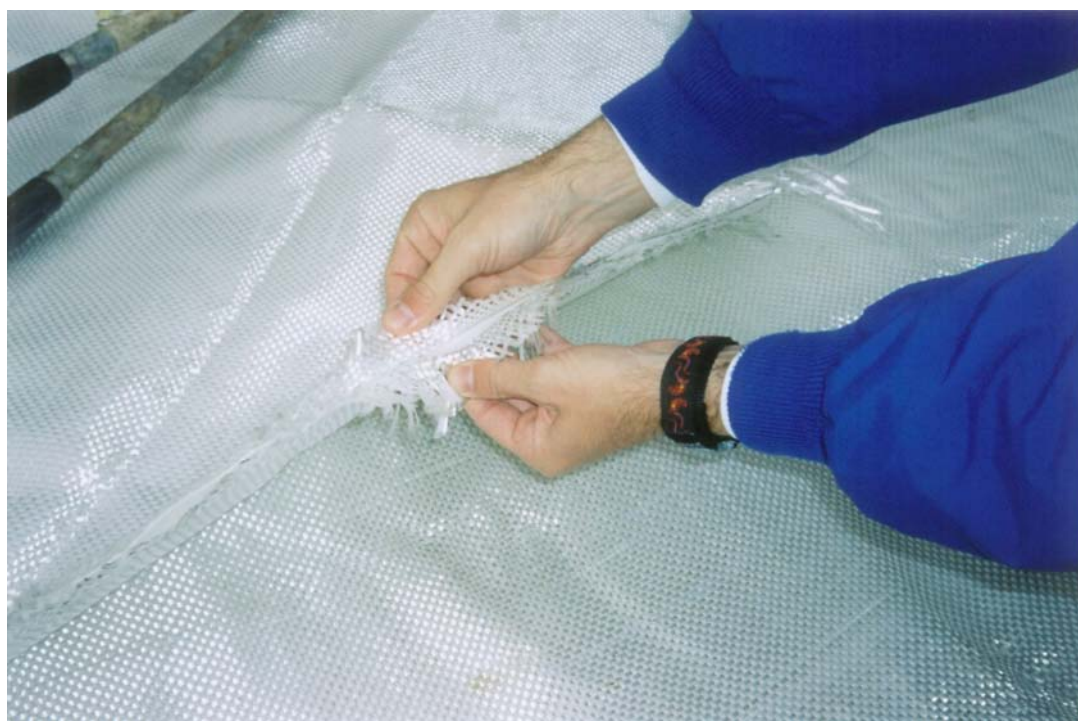
Figure 7-28. Manhole 4

Layering of fiberglass manhole liner prior to wet-out.

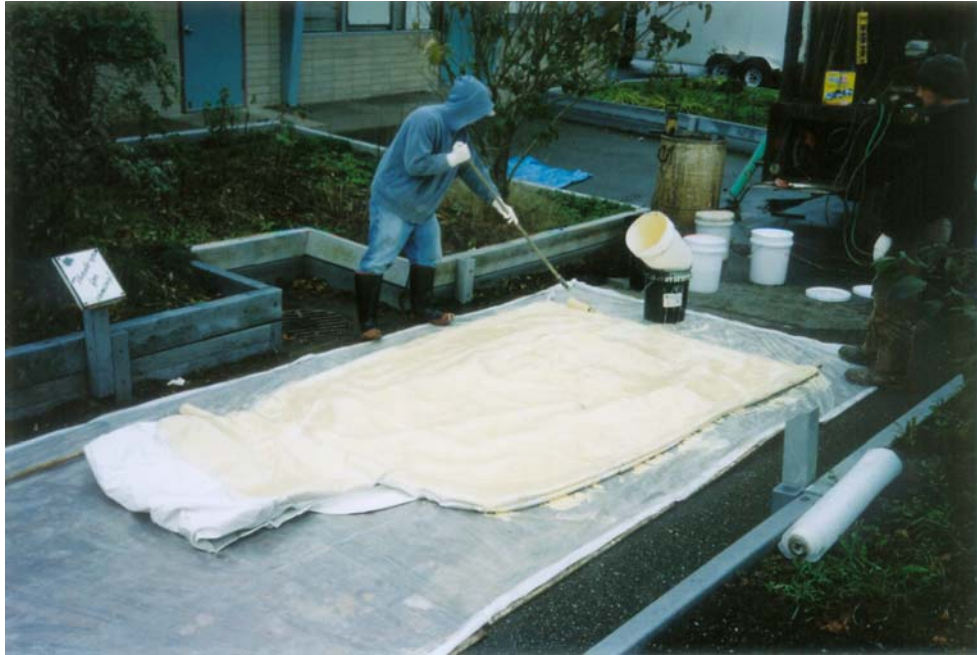
Figure 7-29. Manhole 5

Fiberglass manhole liner being wet-out in the field.

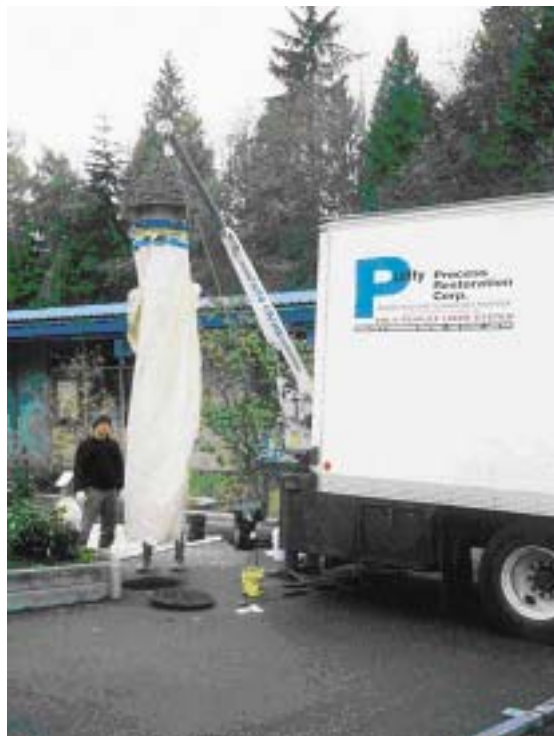
Figure 7-30. Manhole 6

Fiberglass manhole liner being lowered into manhole.

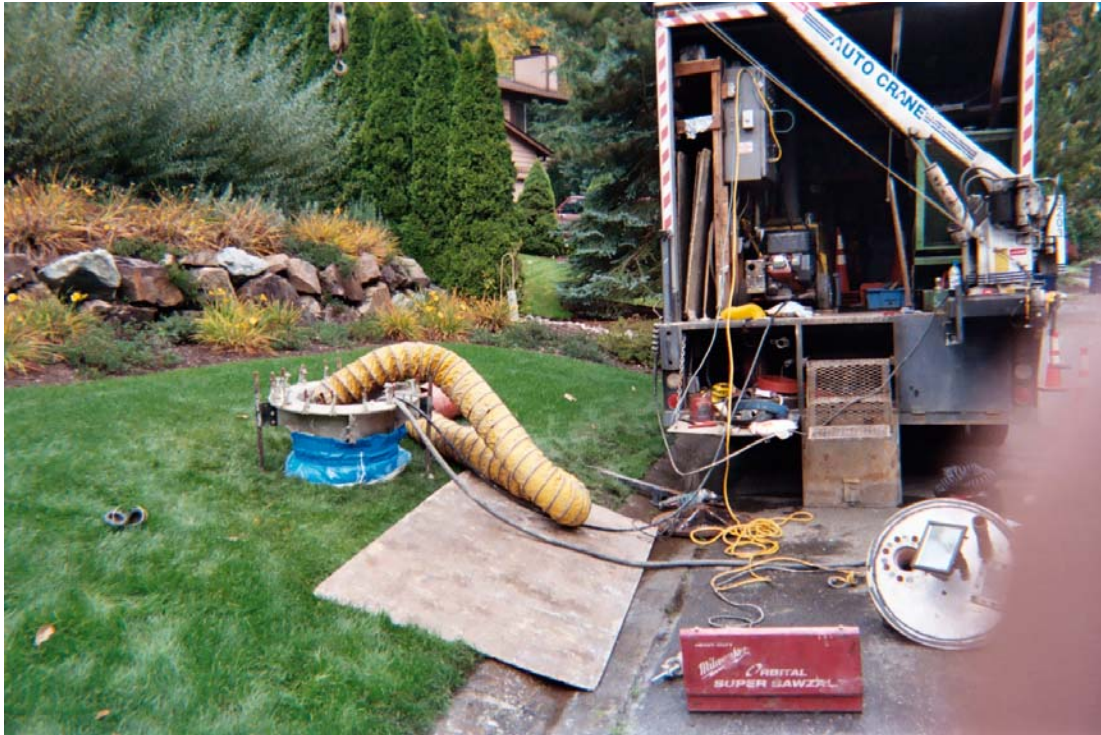
Figure 7-31. Manhole 7

Note the manifold is still attached and the manhole is being ventilated.

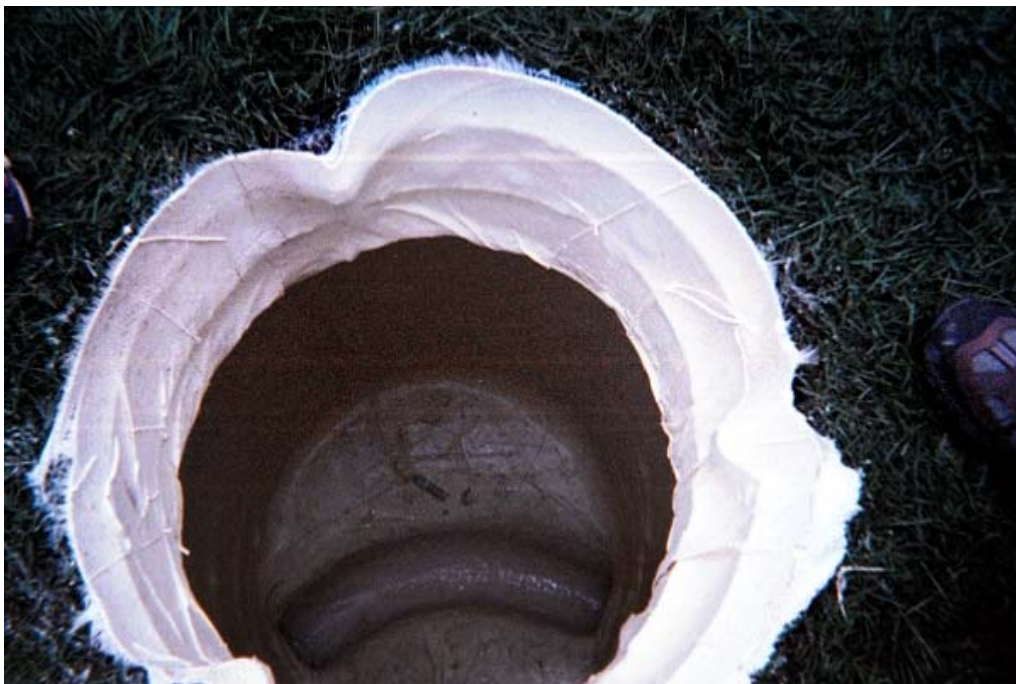
Figure 7-32. Manhole 8

Fiberglass liner before trimming.

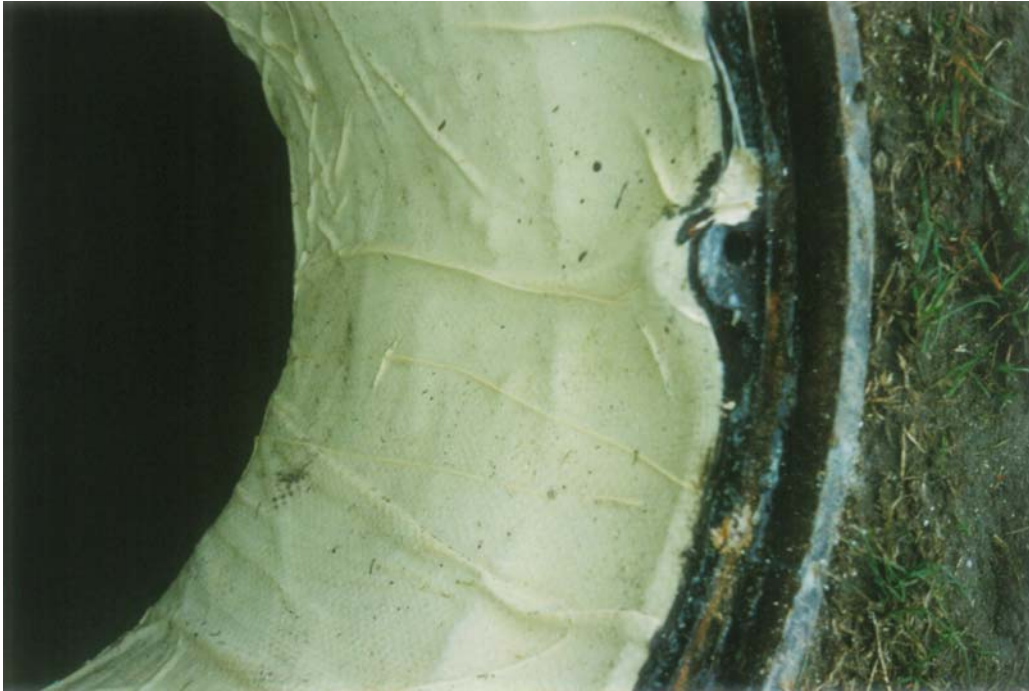
Figure 7-33. Manhole 9

Fiberglass manhole liner trimmed at the manhole ring.

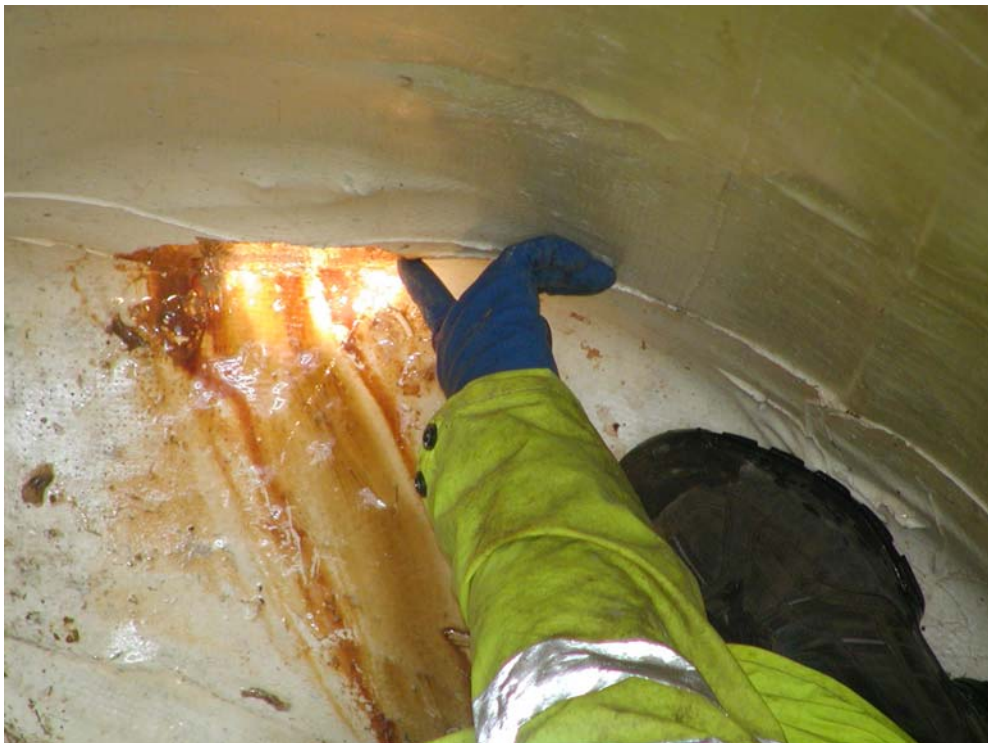
Figure 7-34. Manhole 10

Leak in a cured fiberglass manhole liner.

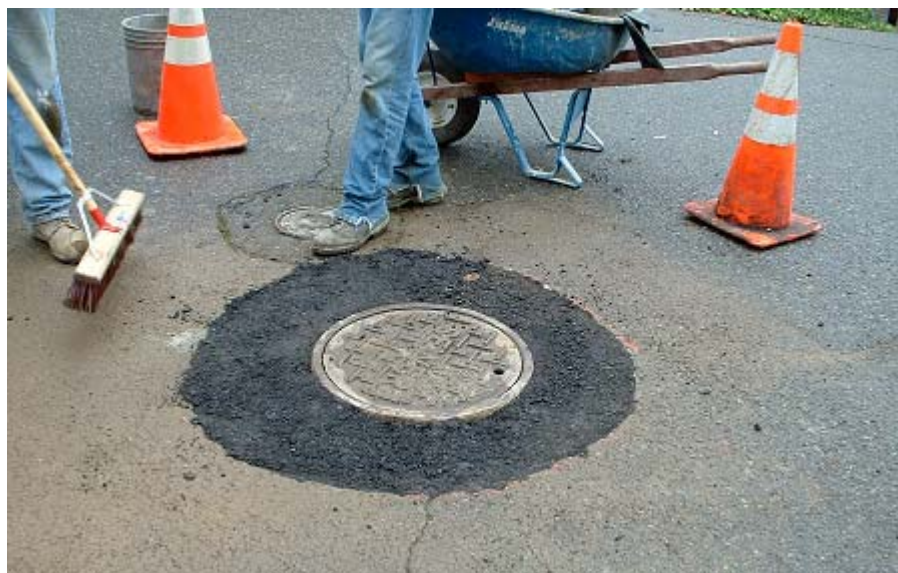
Figure 7-35. Manhole 11

Manhole that has been raised slightly above grade to prevent surface inundation.

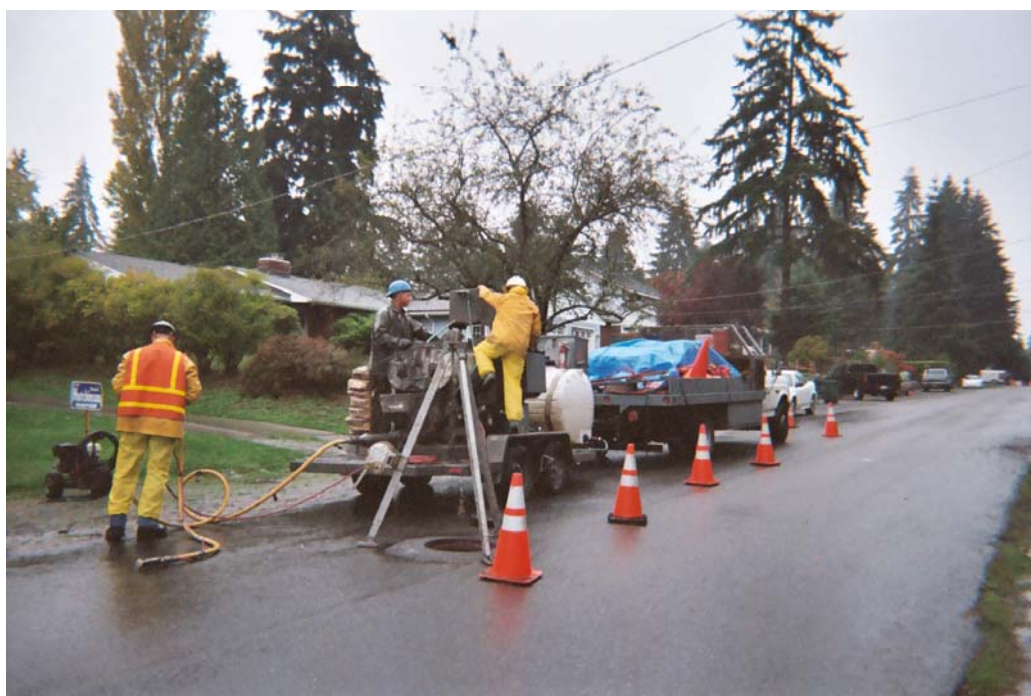
Figure 7-36. Manhole 12

Equipment for spraying cementitious grout on the inside surfaces of a manhole.

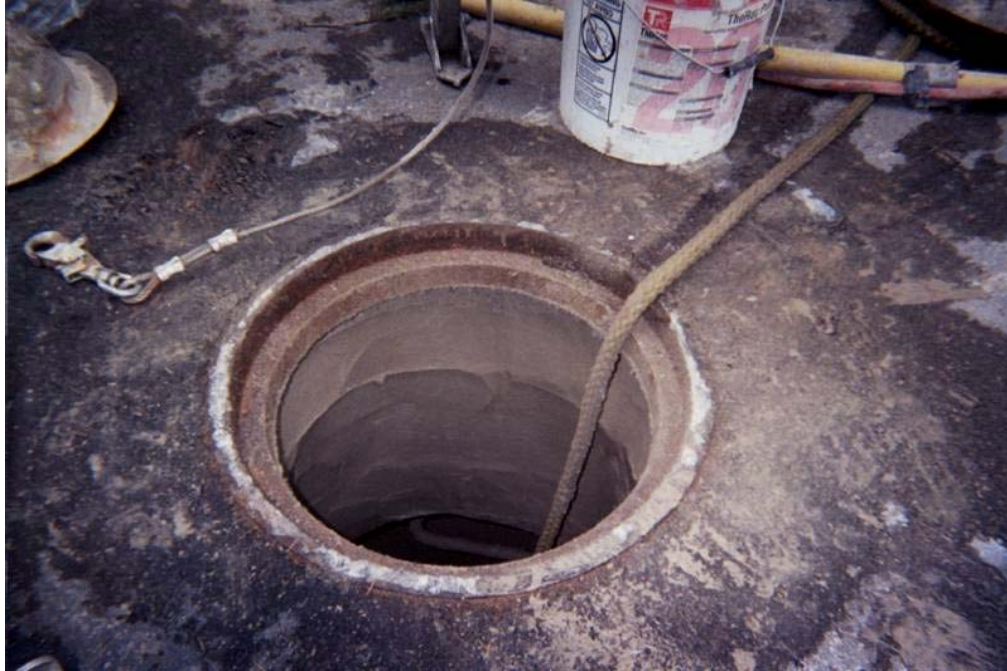
Figure 7-37. Manhole 13

Sprayed-on cementitious grout that has been smoothed with a trowel.

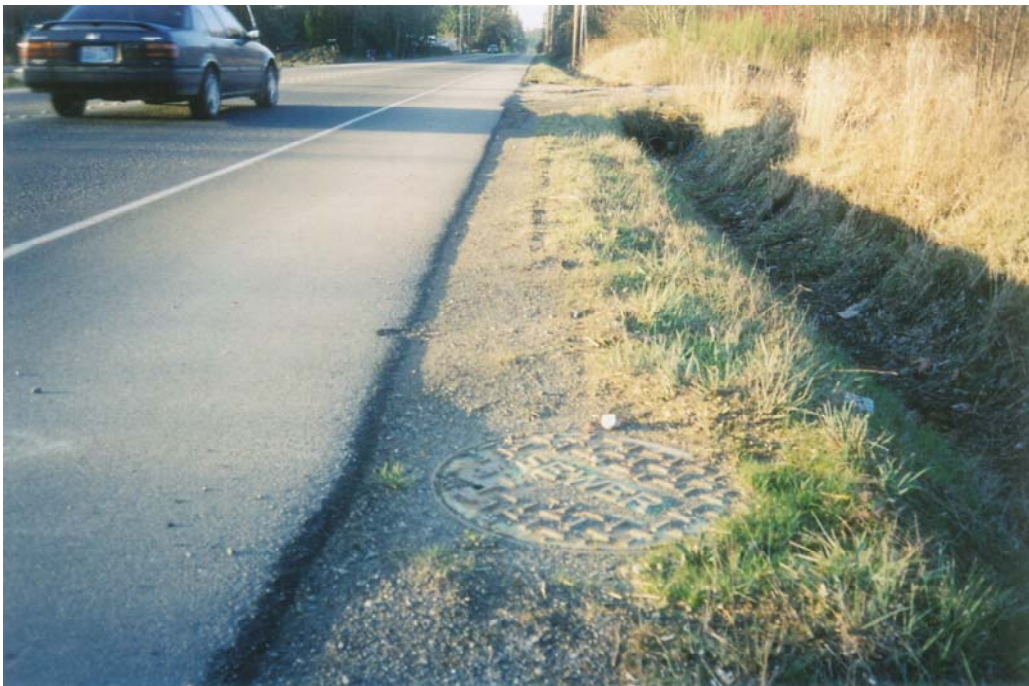
Figure 7-38. Manhole 14

Manhole lid below grade and subject to inundation from surface water running off the roadway.

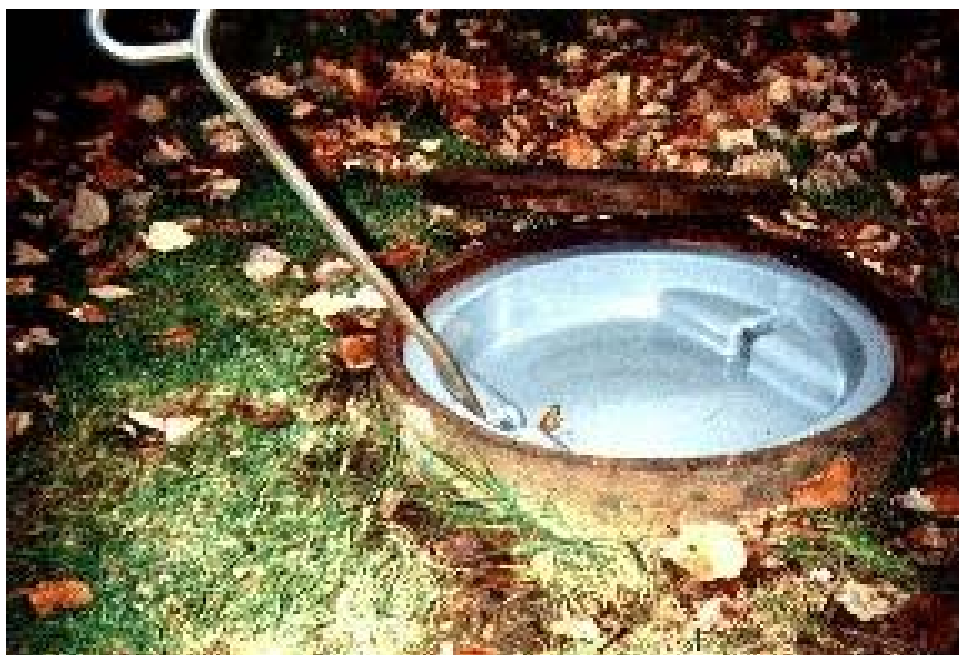
Figure 7-39. Manhole 15

Manhole pan in place. Lid will fit back in place on frame.
